## EXAMPLES OF MOLD INFESTATIONS

## MOLD REMEDIATION ISSUES

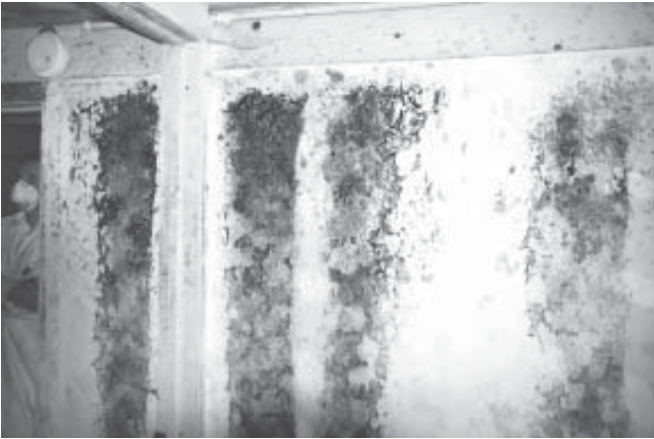
Figure 1

**Mold on basement walls**—Figures 1 and 2 (next page) show the amount of mold infestation that occurred when water pipes froze and burst during the winter. The water was turned off, but, within six months, mold had infested the entire basement. The estimates to clean up the mold far exceeded the value of the house—so it was demolished! This is a common outcome when a house has been neglected for months after water damage.

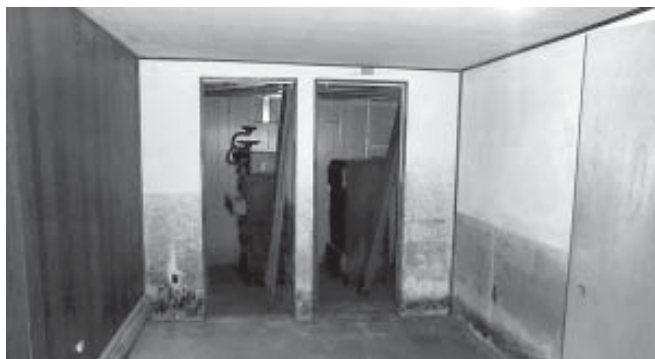
This picture exhibits one outcome when a home is flooded. In the U.S., hundreds of homes get flooded each year, and many of them are never properly remediated. Flooded houses can quickly develop heavy mold infestation, and the “Sick Building Syndrome” if they are not properly and completely cleaned up.
